# Manhole Inspection Summary

Manhole # S25AA\_008MH

**Location** Address: **905 FREMONT AVE**

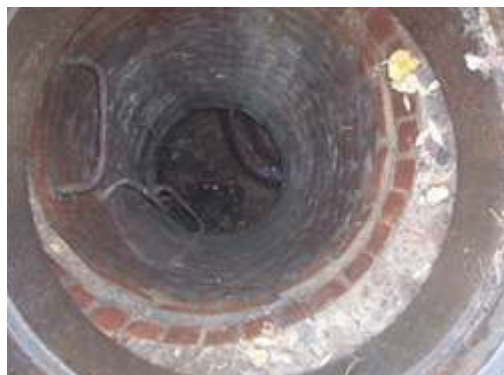
Top View

Comments **RETOOK TOP VIEW PHOTO. TOP VIEW DOES NOT SHOW CONNECTIVITY DUE TO CHANNEL OFFSET CONDITION. 4-17-09**
